PROJECT CHECO SOUTHEAST ASIA REPORT

SECOND GENERATION WEAPONRY IN SEA

10 SEPTEMBER 1970

HQ PACAF

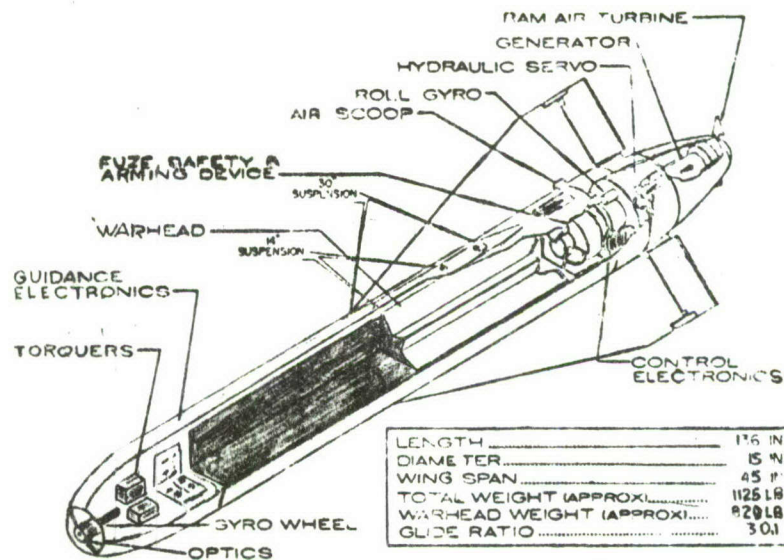
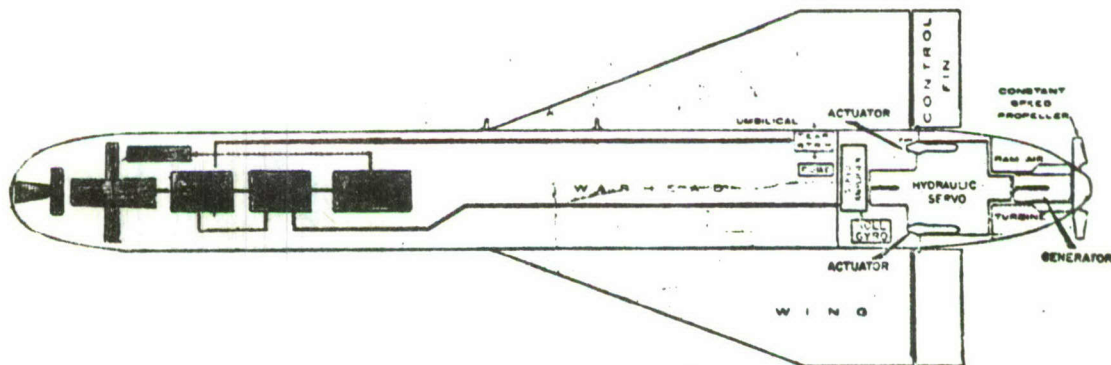
FIGURE 1

Aircrews believed the two-man concept of the F-4D constituted a definite advantage in technique for use of the AGM-62. After visually acquiring and identifying his target, the aircraft commander placed it under his gunsight piper. This allowed him to keep his head up out of the cockpit and, since the weapon was in boresight mode, place the target near the center of the video display. The Guy in Back (GIB) then located and identified the target on his display and aligned it in the "gate" (four intersecting lines constituting a 2.6 mil look-angle in the center of the display, within which the missile tracked upon release), and locked-on. After lock-on, and while the aircraft was in the delivery envelope, the aircraft commander verified the target on his display and assumed the lock in the front seat. After his launch, the pilot was free of any requirement to guide it visually and he could take whatever evasive action was deemed necessary. The weapon continued to "home" on the area of greatest contrast within the 2.6 mil tracking gate. The flexibility of the weapon/airframe combination allowed electronic countermeasures (ECM) pod formation to be flown up to, and even during, simultaneous launch; or, if outside SAM threat areas, a fluid four formation could be flown for better MIG defense.^{26/} (Fig. 1 shows schematic

WALLEYE FUNCTIONAL BLOCK DIAGRAM

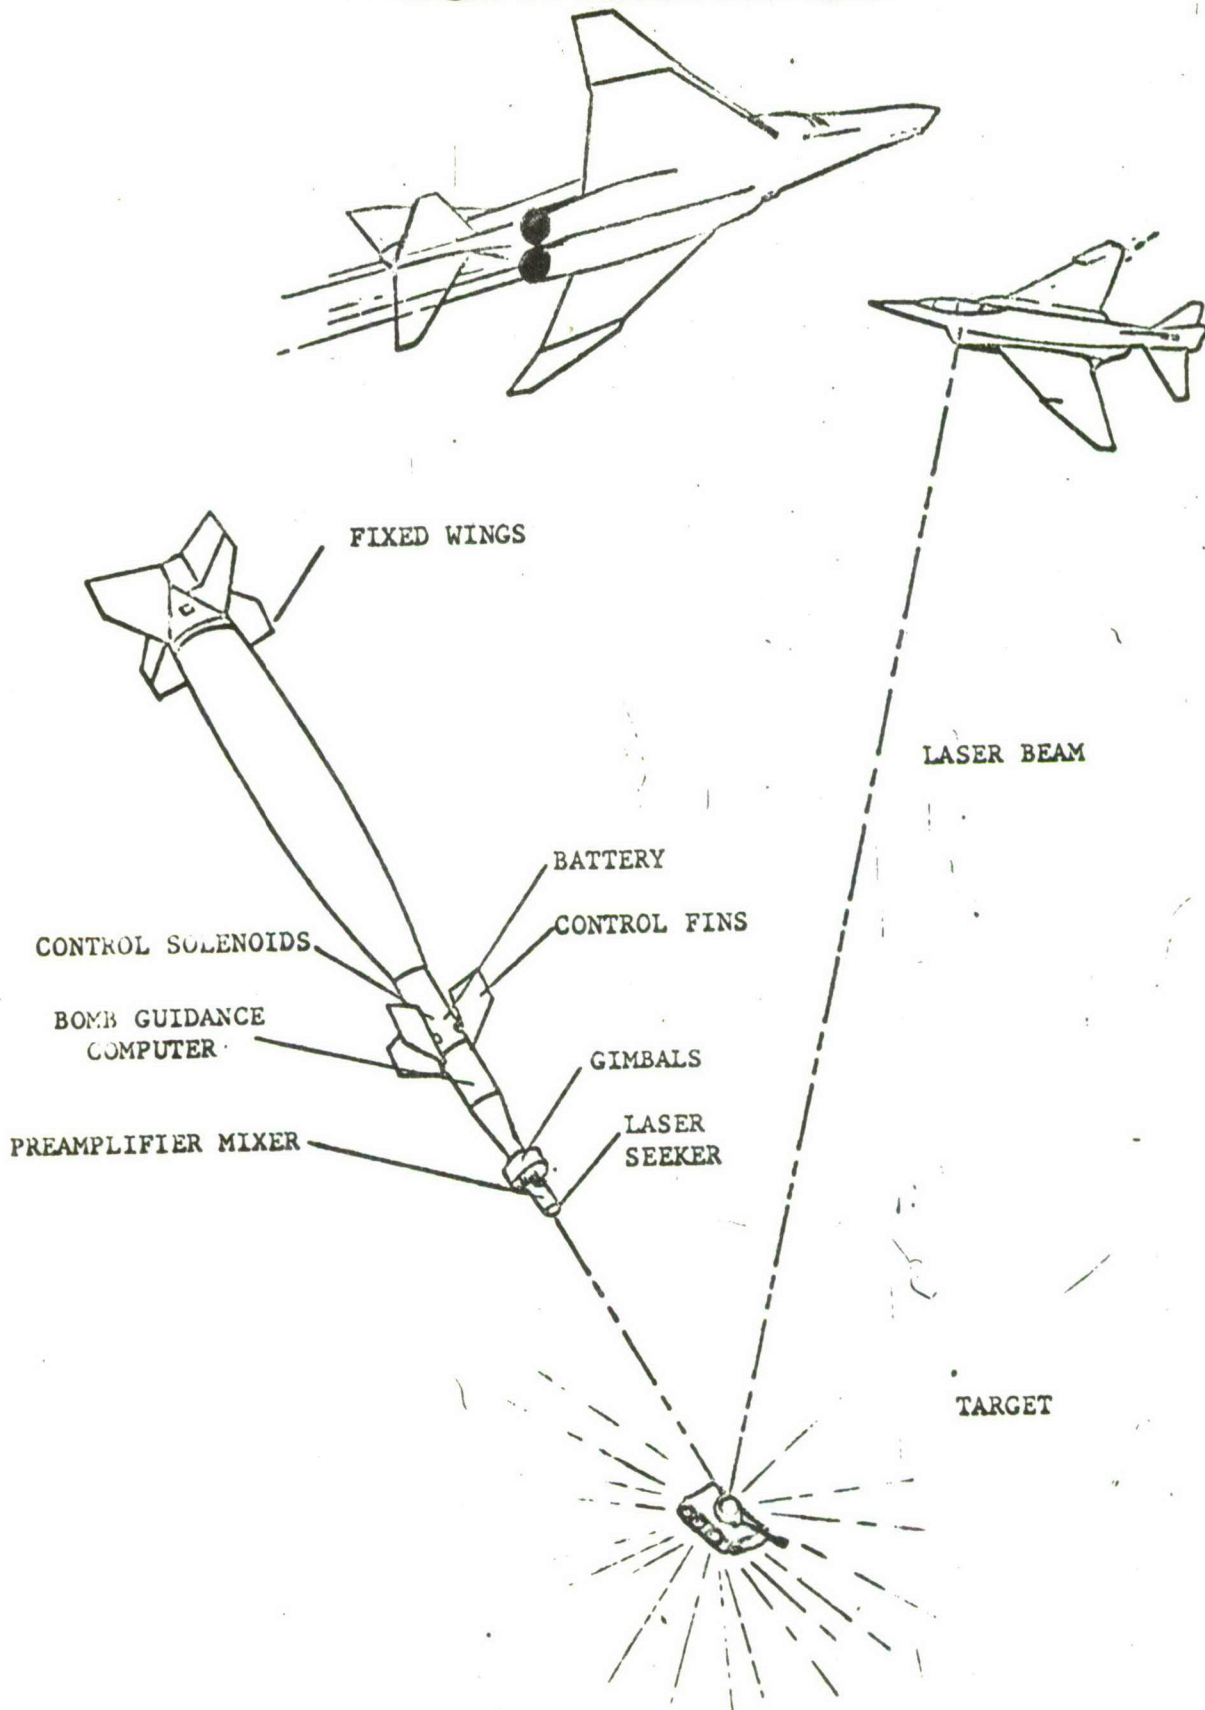
Having "found" its illuminated aiming point, the seeker attempted to keep the target centered at the intersection of its four-quadrant silicon detector. Through adapted plumbing for the SHRIKE missile control system, the seeker activated canard fins which directed the bomb toward its target. The movable fins operated in an "on-off" fashion, either fully deflected or released to return to the slipstream as directed by the seeker unit. The fins made the flight of the bomb what aircrews described as an undulating glide rather than a smooth continuous arc toward the target.^{5/} To compensate for the abrupt moments of force imposed by the canard controls, augmented roll stabilization fins were attached to the MK-84 body. (Fig. 2)

PAVE WAY I (MK 84/KMU 351)

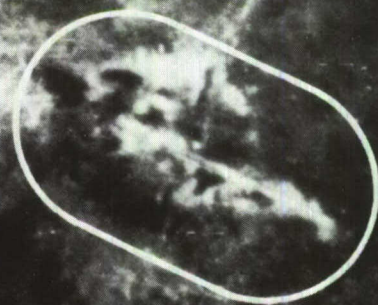
FIGURE 3

A pictorial drama verifying the validity of the suggestion began on 23 October 1969 when a film frame from a photo reconnaissance mission revealed the existence of a 100-mm AAA gun two and a half miles southwest of the Ban Karai Pass, one of the most heavily traveled infiltration routes from North Vietnam into Laos. The weapon was deeply revetted and well masked by surrounding vegetation and, with its effective range approaching 40,000 feet, posed a definite threat to U.S. interdiction efforts along Route 912.^{52/} The area was surrounded by towering karst, making the selection of run-in headings difficult, and the undeniable power of the gun emphasized the old axiom: "Don't get into a spitting contest with antiaircraft guns!" Nonetheless, it was necessary that the heavy AAA weapon be neutralized. (Fig. 3)

"TAC RECCE"
100 MM AAA GUN
2.5 NM SW BAN KARAI PASS
23 OCT 69 APRX TOT: H30H
DEYT 507Q FRAME: 8IRLS
171539N1060908E
6884

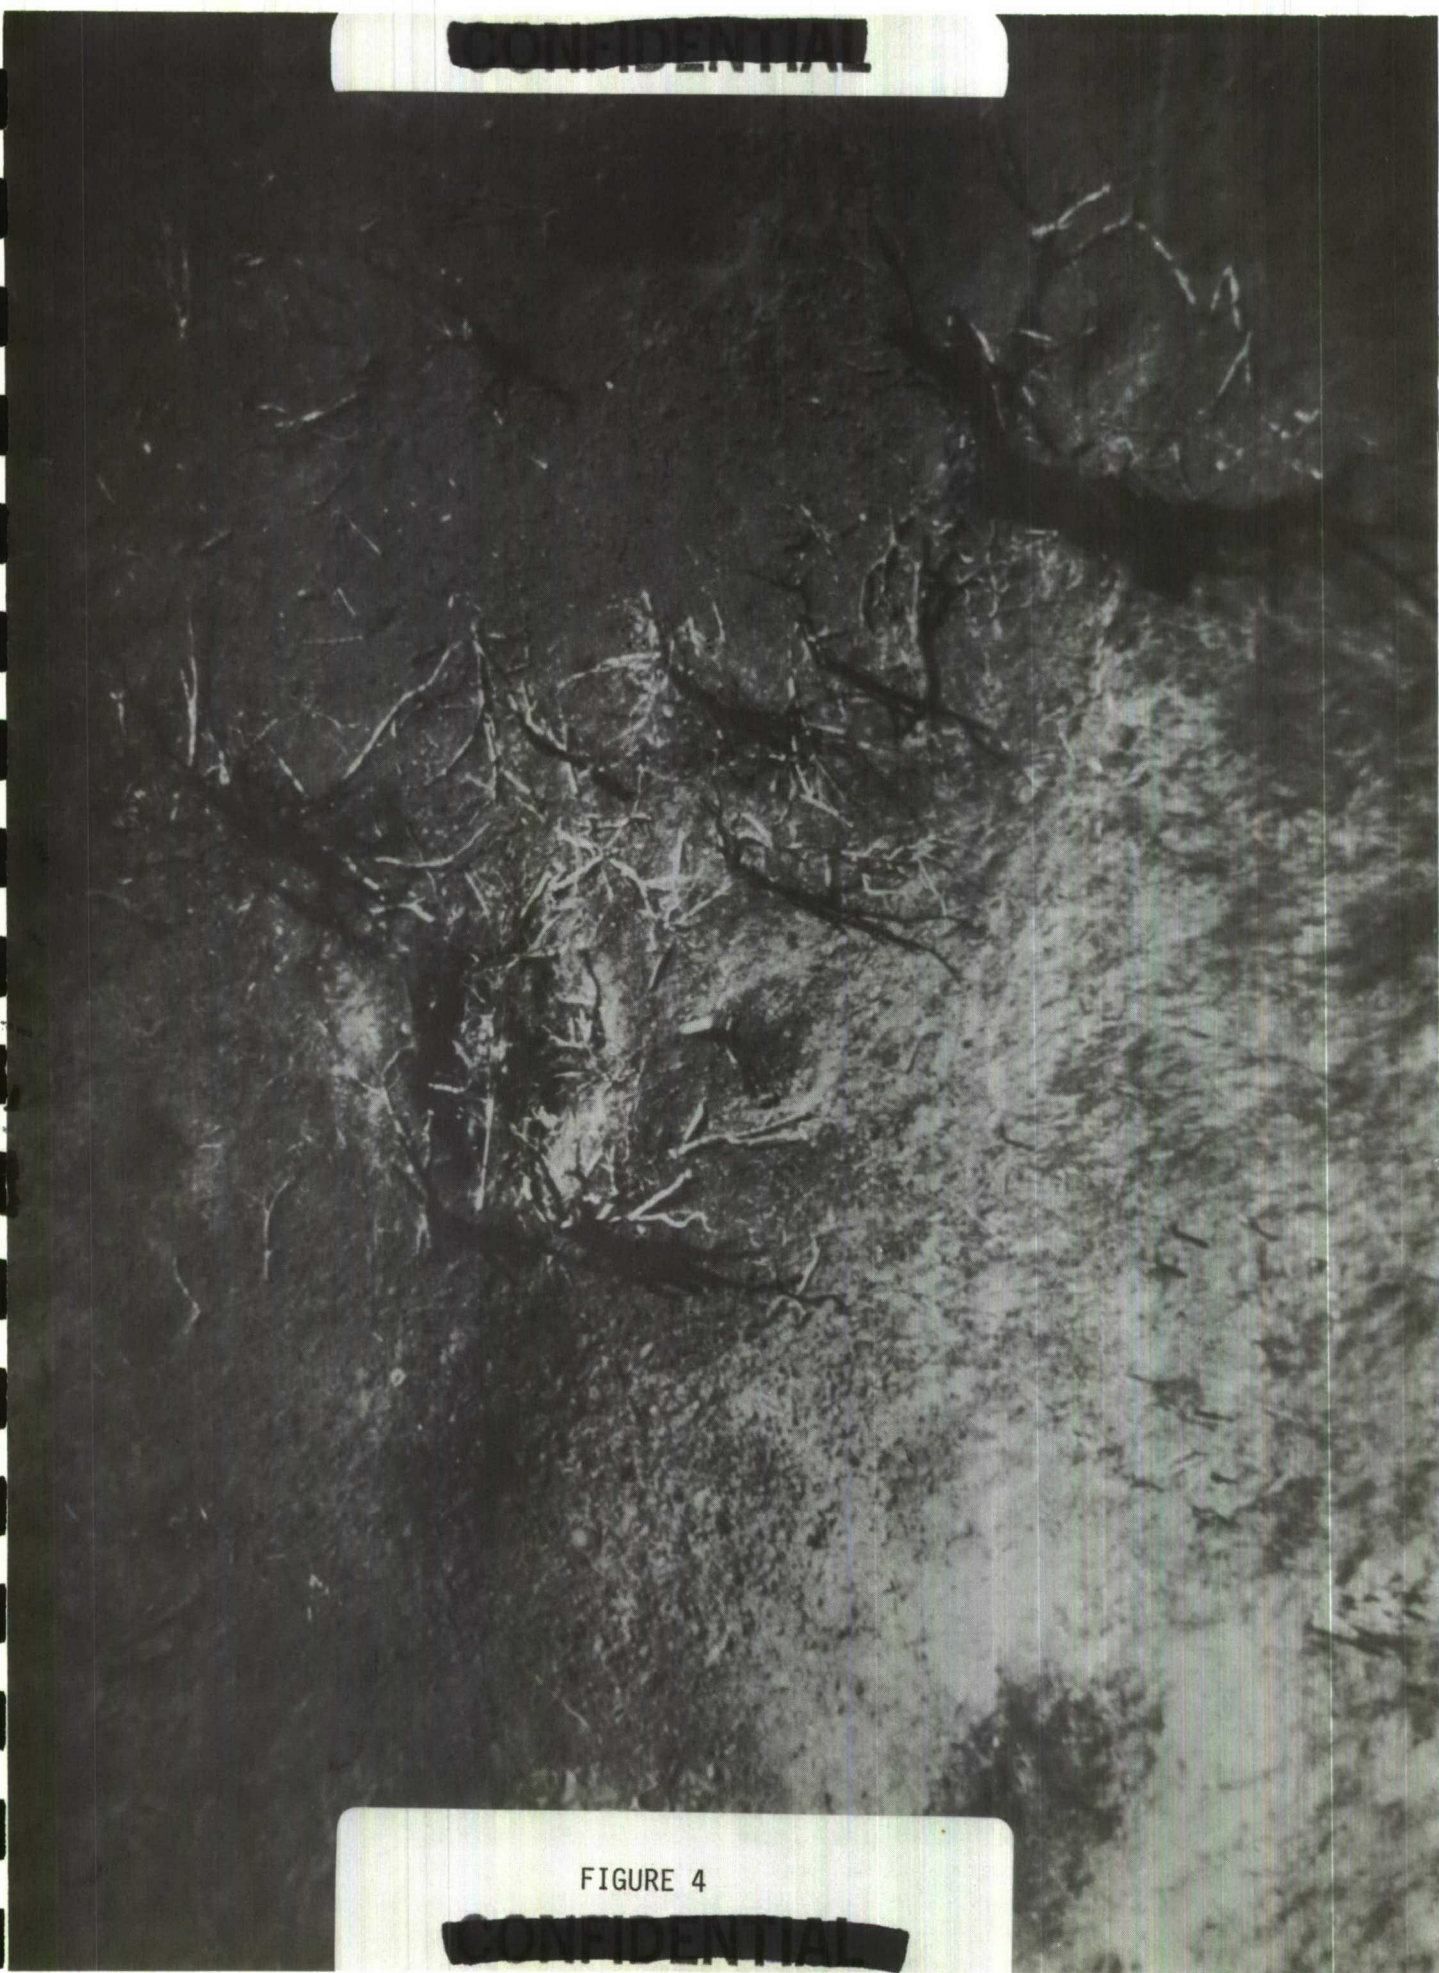
FIGURE 4

The first strike was placed on the site on 13 November 1969, using the Bolt M-118. The PAVE WAY impacted 13 to 14 feet from the rim of the revetment, and the site was silenced, the gunpit filled with debris, and the surrounding area stripped of foliage for a hundred feet. The revetment wall, however, provided sufficient protection so that the gun remained intact. (Fig. 4)

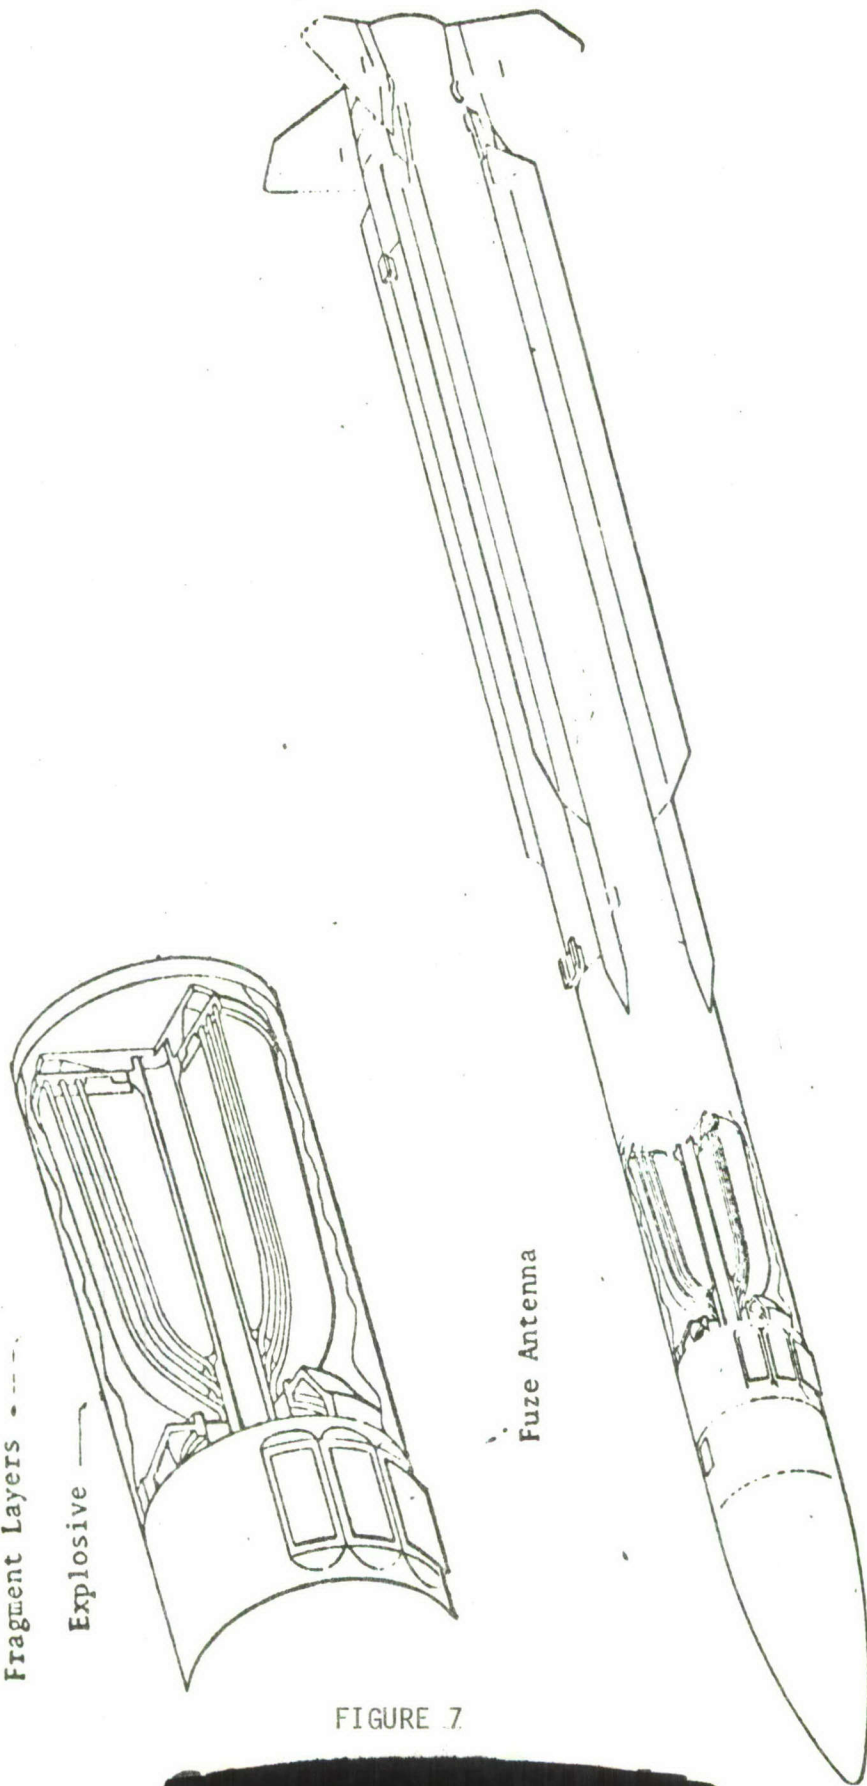
FIGURE 7

Fuze Antenna

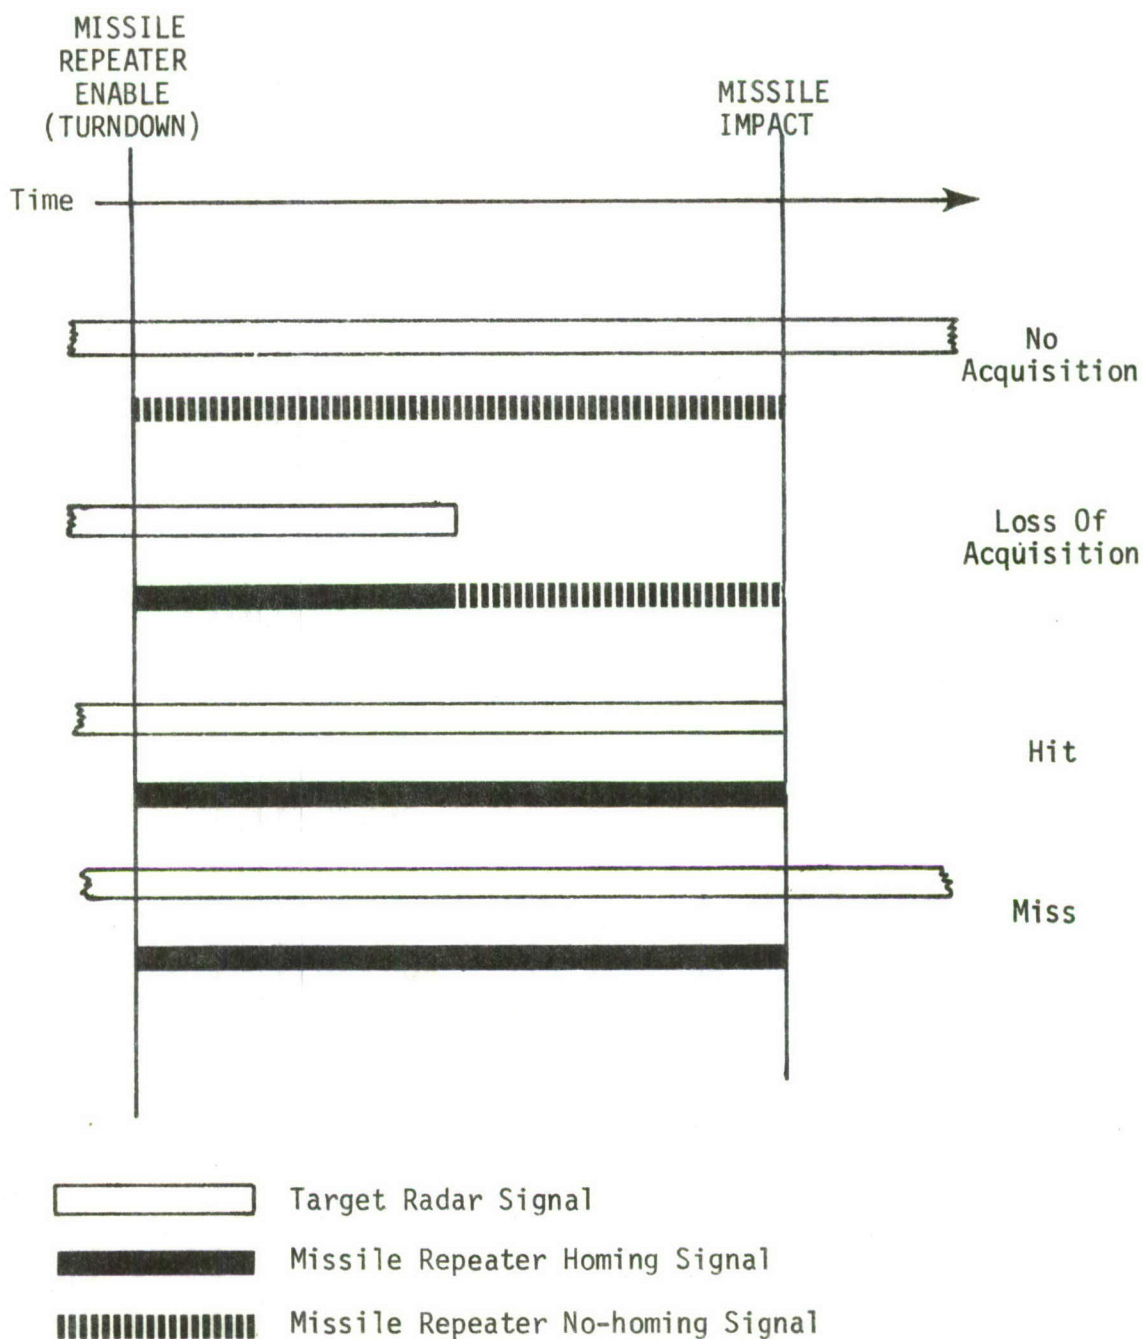
FIGURE 8

AGM-78 Electronic BDA Logic and Indications

If the SHRIKE was a first generation anti-radiation missile, continuing improvements to the STANDARD ARM unquestionably placed it in the second generation category. As mentioned previously, one of the serious deficiencies of the early SHRIKE was the difficulty of obtaining valid BDA, or under certain conditions, even determining where and when the missile detonated. Under visual conditions, the insertion of a spotting charge in the missile could show the point of impact, but actual damage assessment remained questionable. With this in mind, an electronic BDA subsystem was developed and incorporated into late model STANDARD ARMs.^{15/} With the BDA system to keep score by registering hits, and a smoke signal to mark "hit" targets, follow-on aircraft could locate and

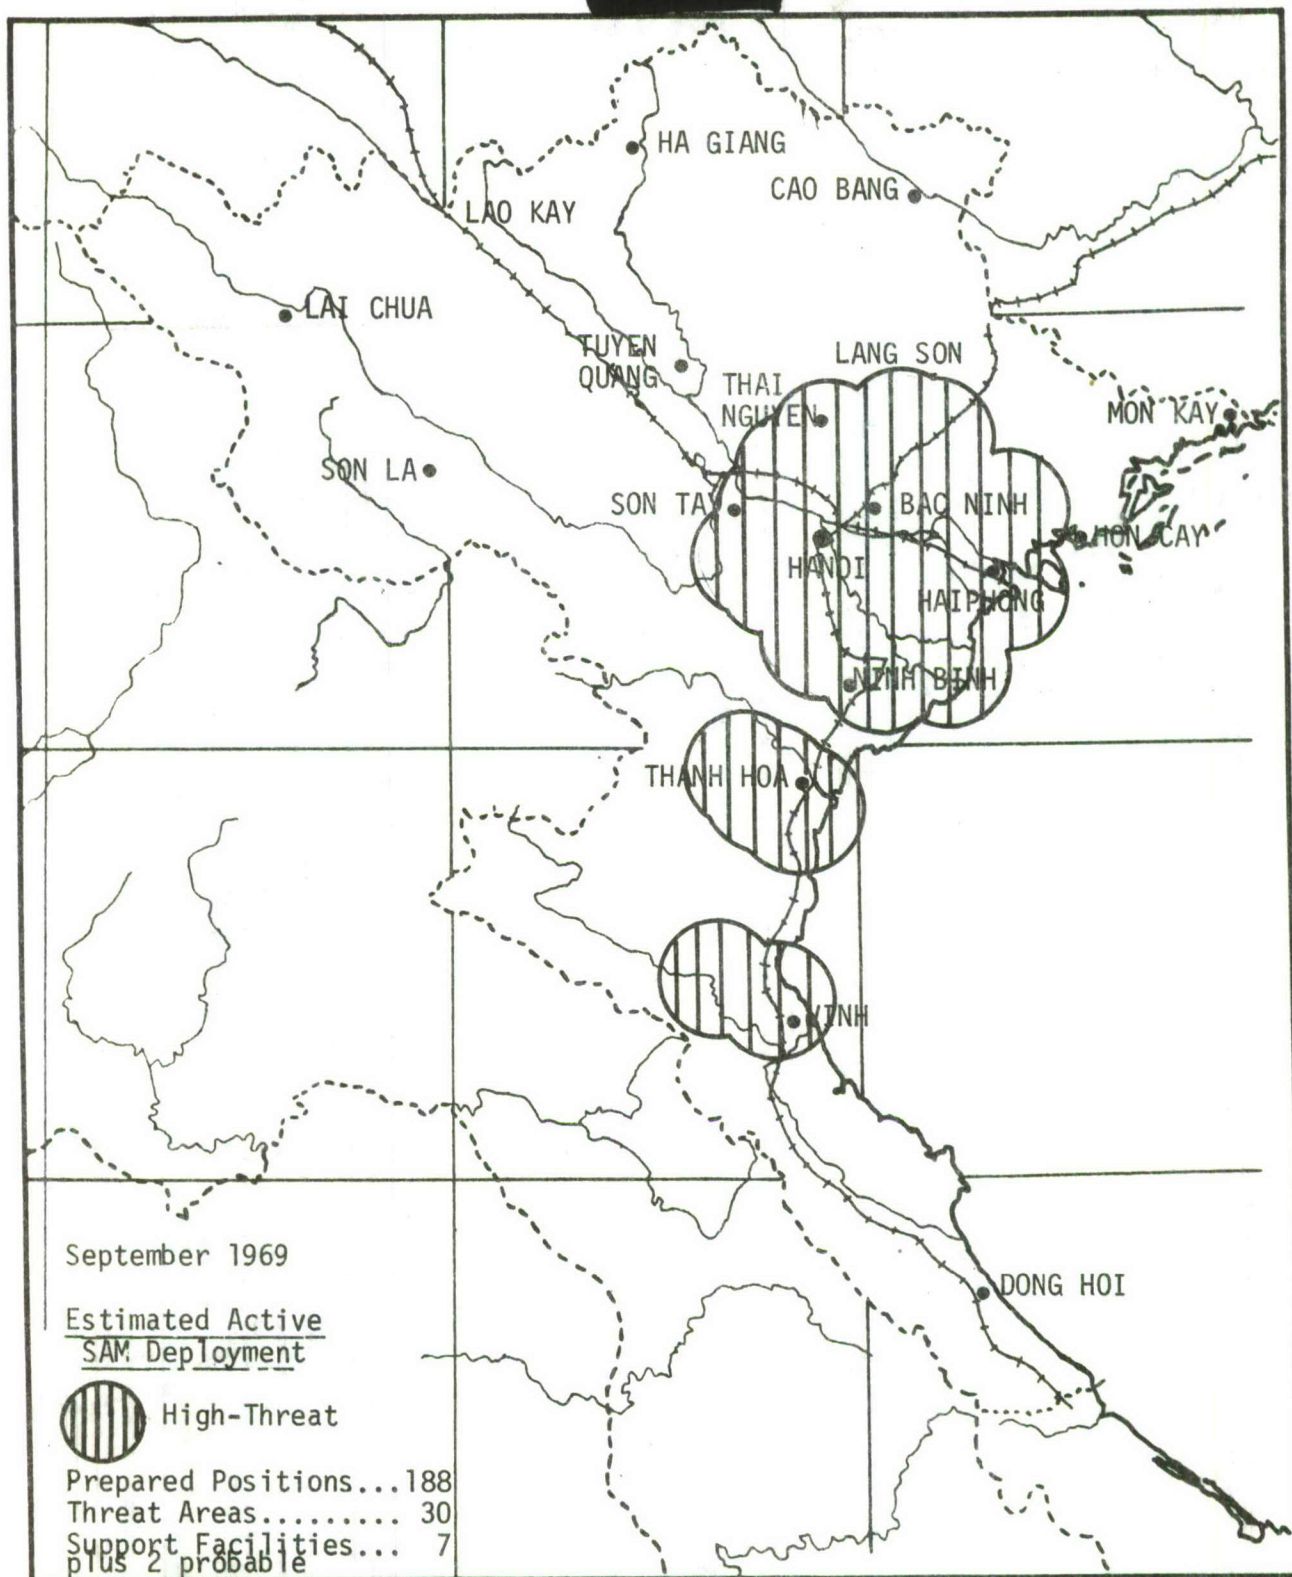
FIGURE 9

Use of the anti-radiation missile had dwindled after the bombing halts, since the majority of high-threat areas were essentially in sanctuary. (Figs. 9, 10) It became apparent in late 1969, however, that the North Vietnamese were increasingly anxious to protect their infiltration routes, Barthelemy, Mu Gia North and South, Nape, and Ban Karai Passes, by moving heavy AAA and SAM installations into these areas. Intelligence figures depicted the high-threat SAM areas in September 1969 as one solid cluster around the Hanoi/Haiphong ring, another around the strategic Thanh Hoa area, and a third at Vinh, which did not impinge upon the Laotian Border.^{18/}

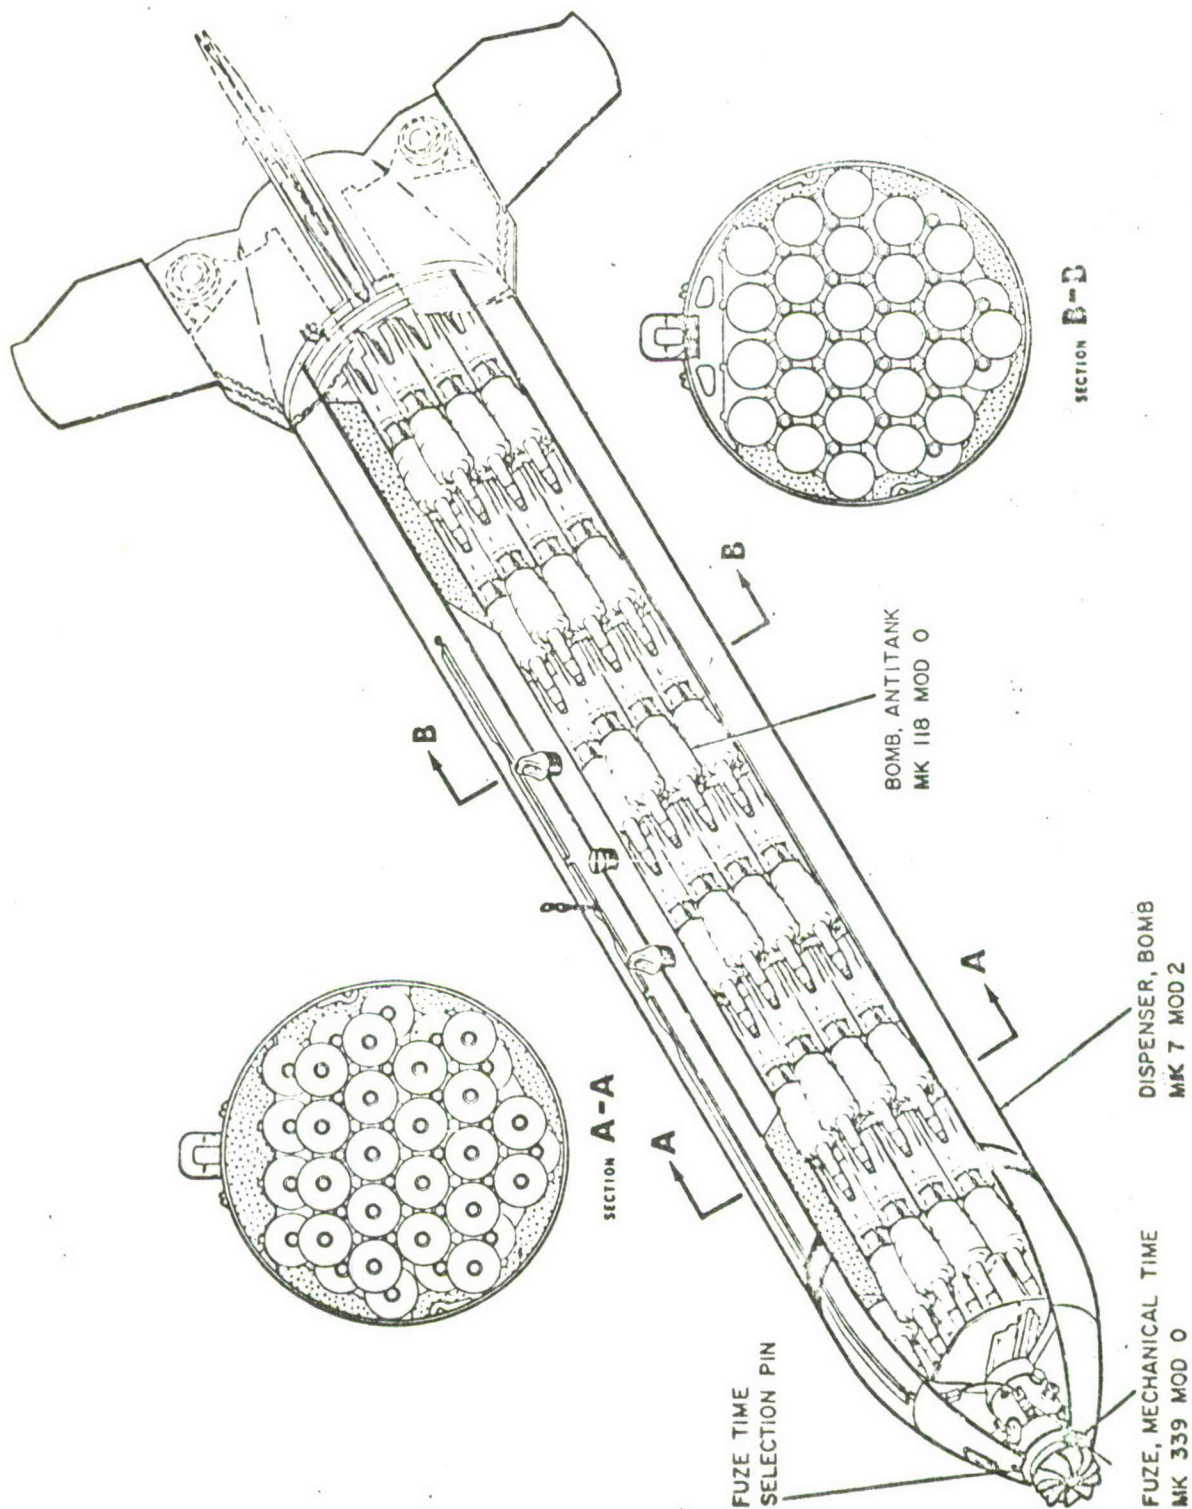
FIGURE 12

— Cutaway of ROCKEYE II showing full bomblet load.

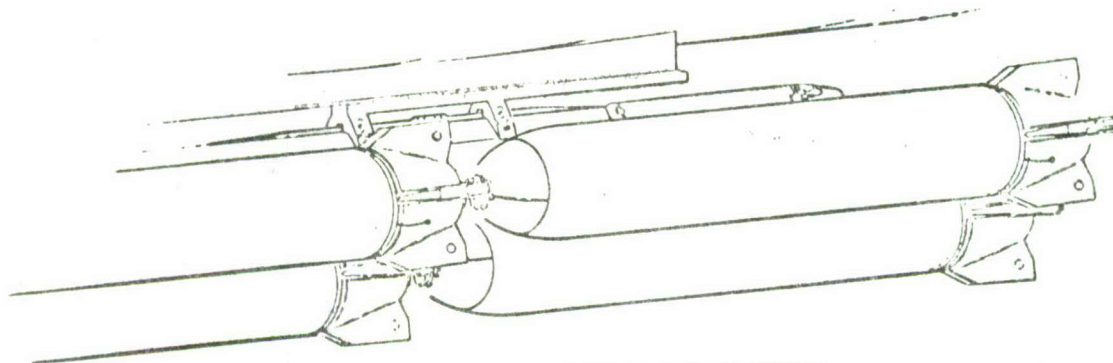
ROCKEYE II MULTIPLE EJECTOR RACK CARRIAGE

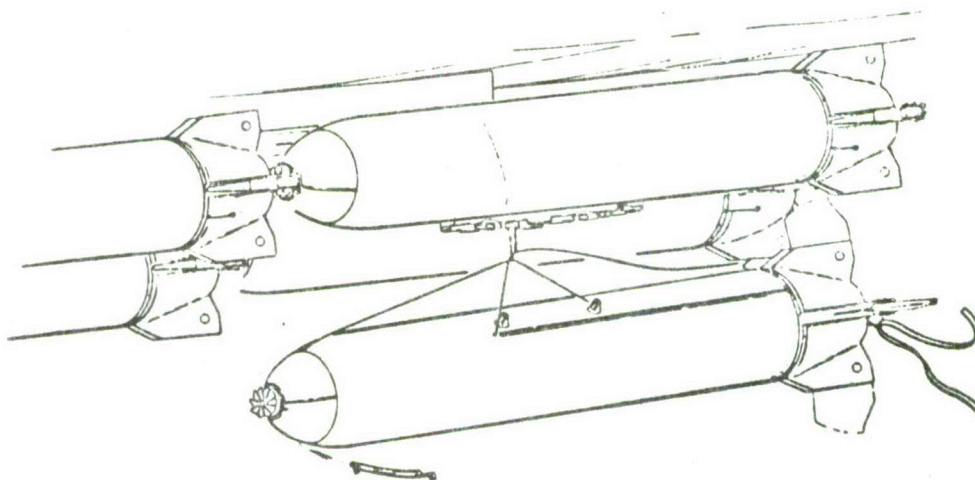
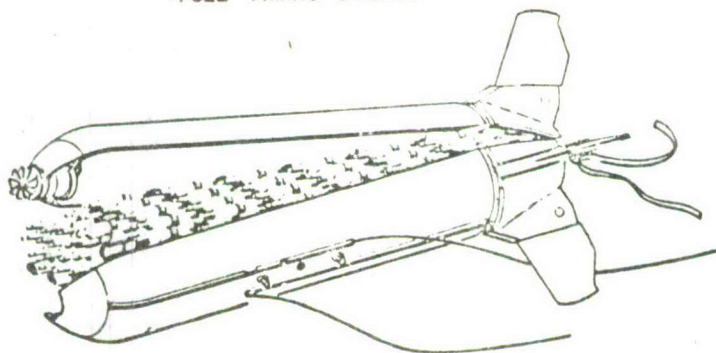
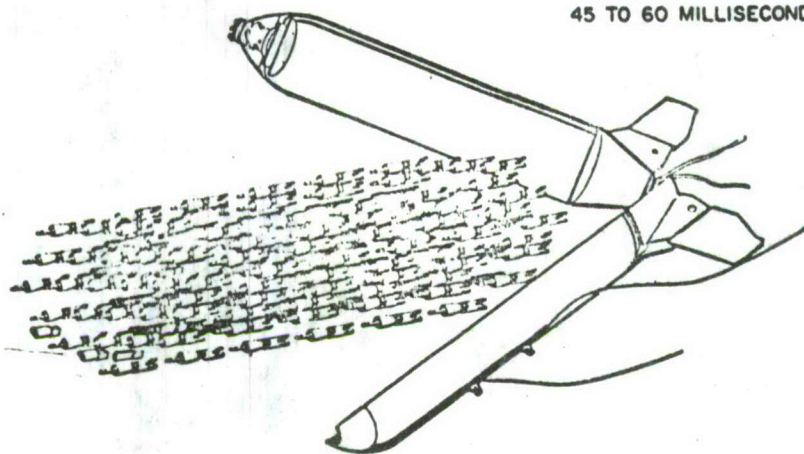
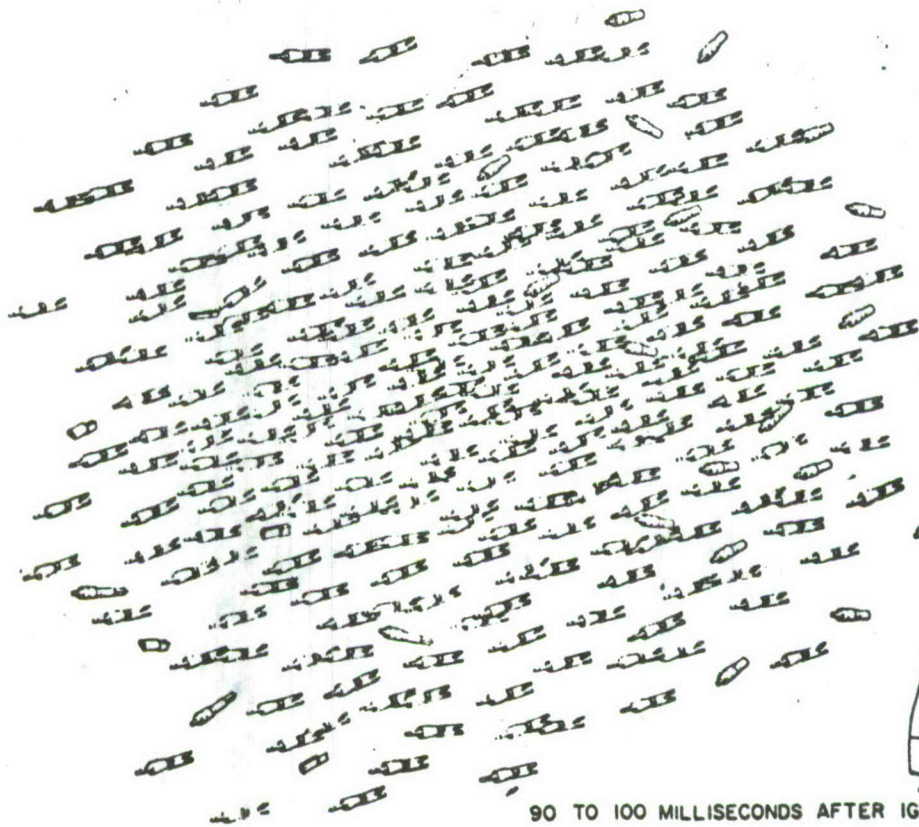
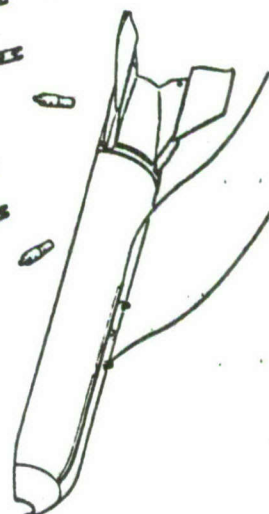
FIGURE 13

ARMING WIRE EXTRACTION
FIN RELEASE BAND SEPARATION
FUZE RELEASE BAND SEPARATION
FUZE TIMING STARTS

15 TO 25 MILLISECONDS AFTER IGNITION

45 TO 60 MILLISECONDS AFTER IGNITION

90 TO 100 MILLISECONDS AFTER IGNITION

— ROCKEYE II operational sequence.

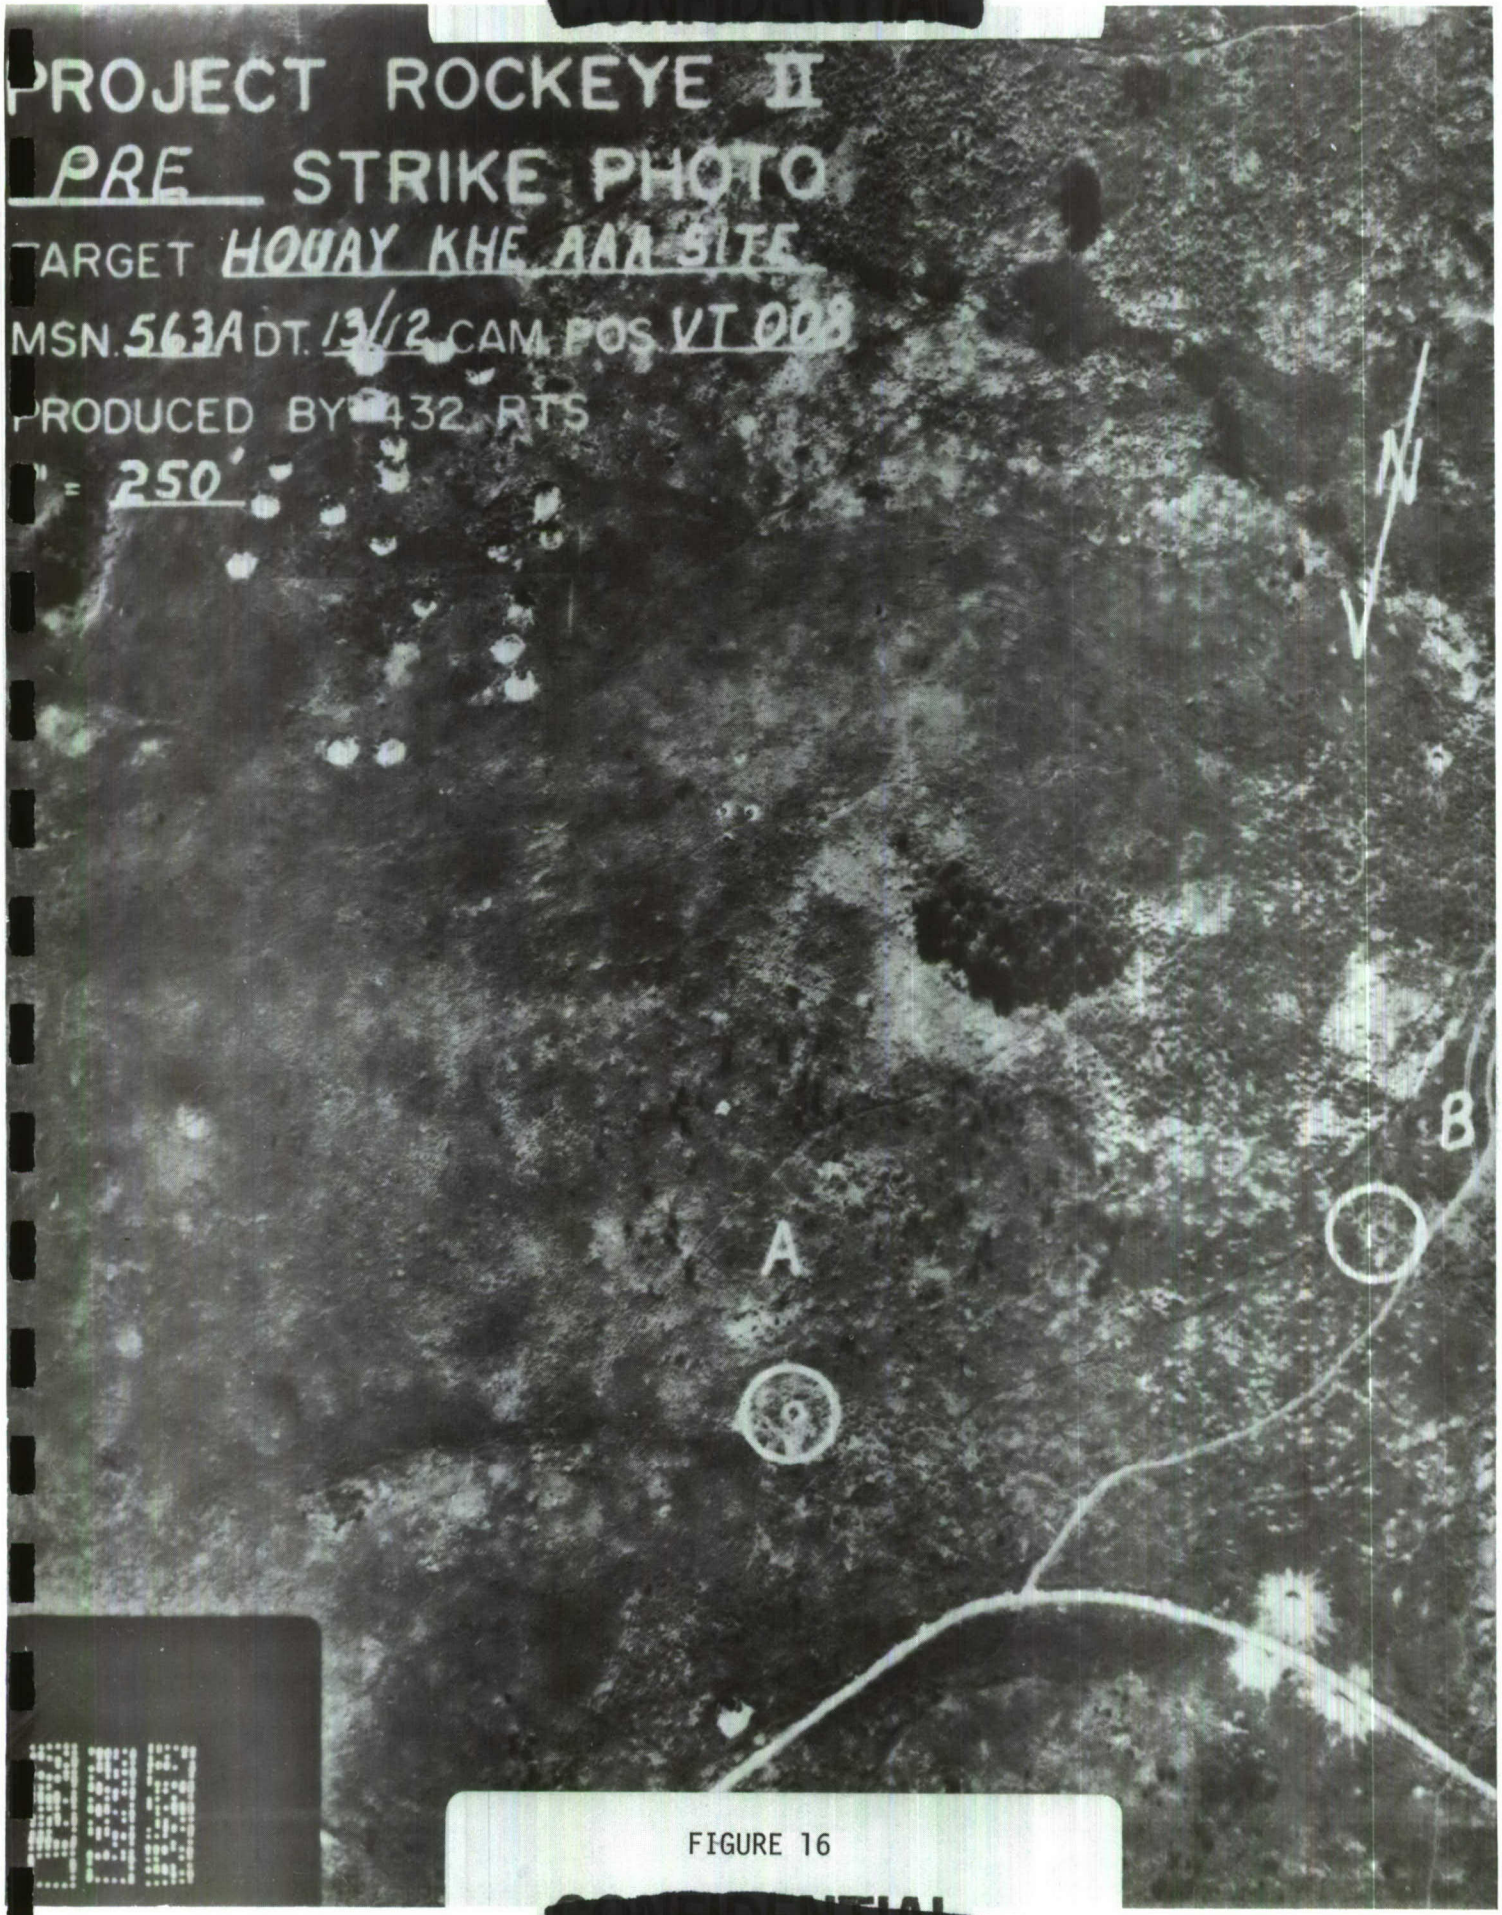
FIGURE 16

As an illustration of a fairly typical ROCKEYE II strike, Day 2 provided a good example. Pre- and post-strike photography showed pattern and coverage of at least one of the ROCKEYE canisters and also illustrated the difficulty of interpreting valid BDA. (Figs. 16, 17)

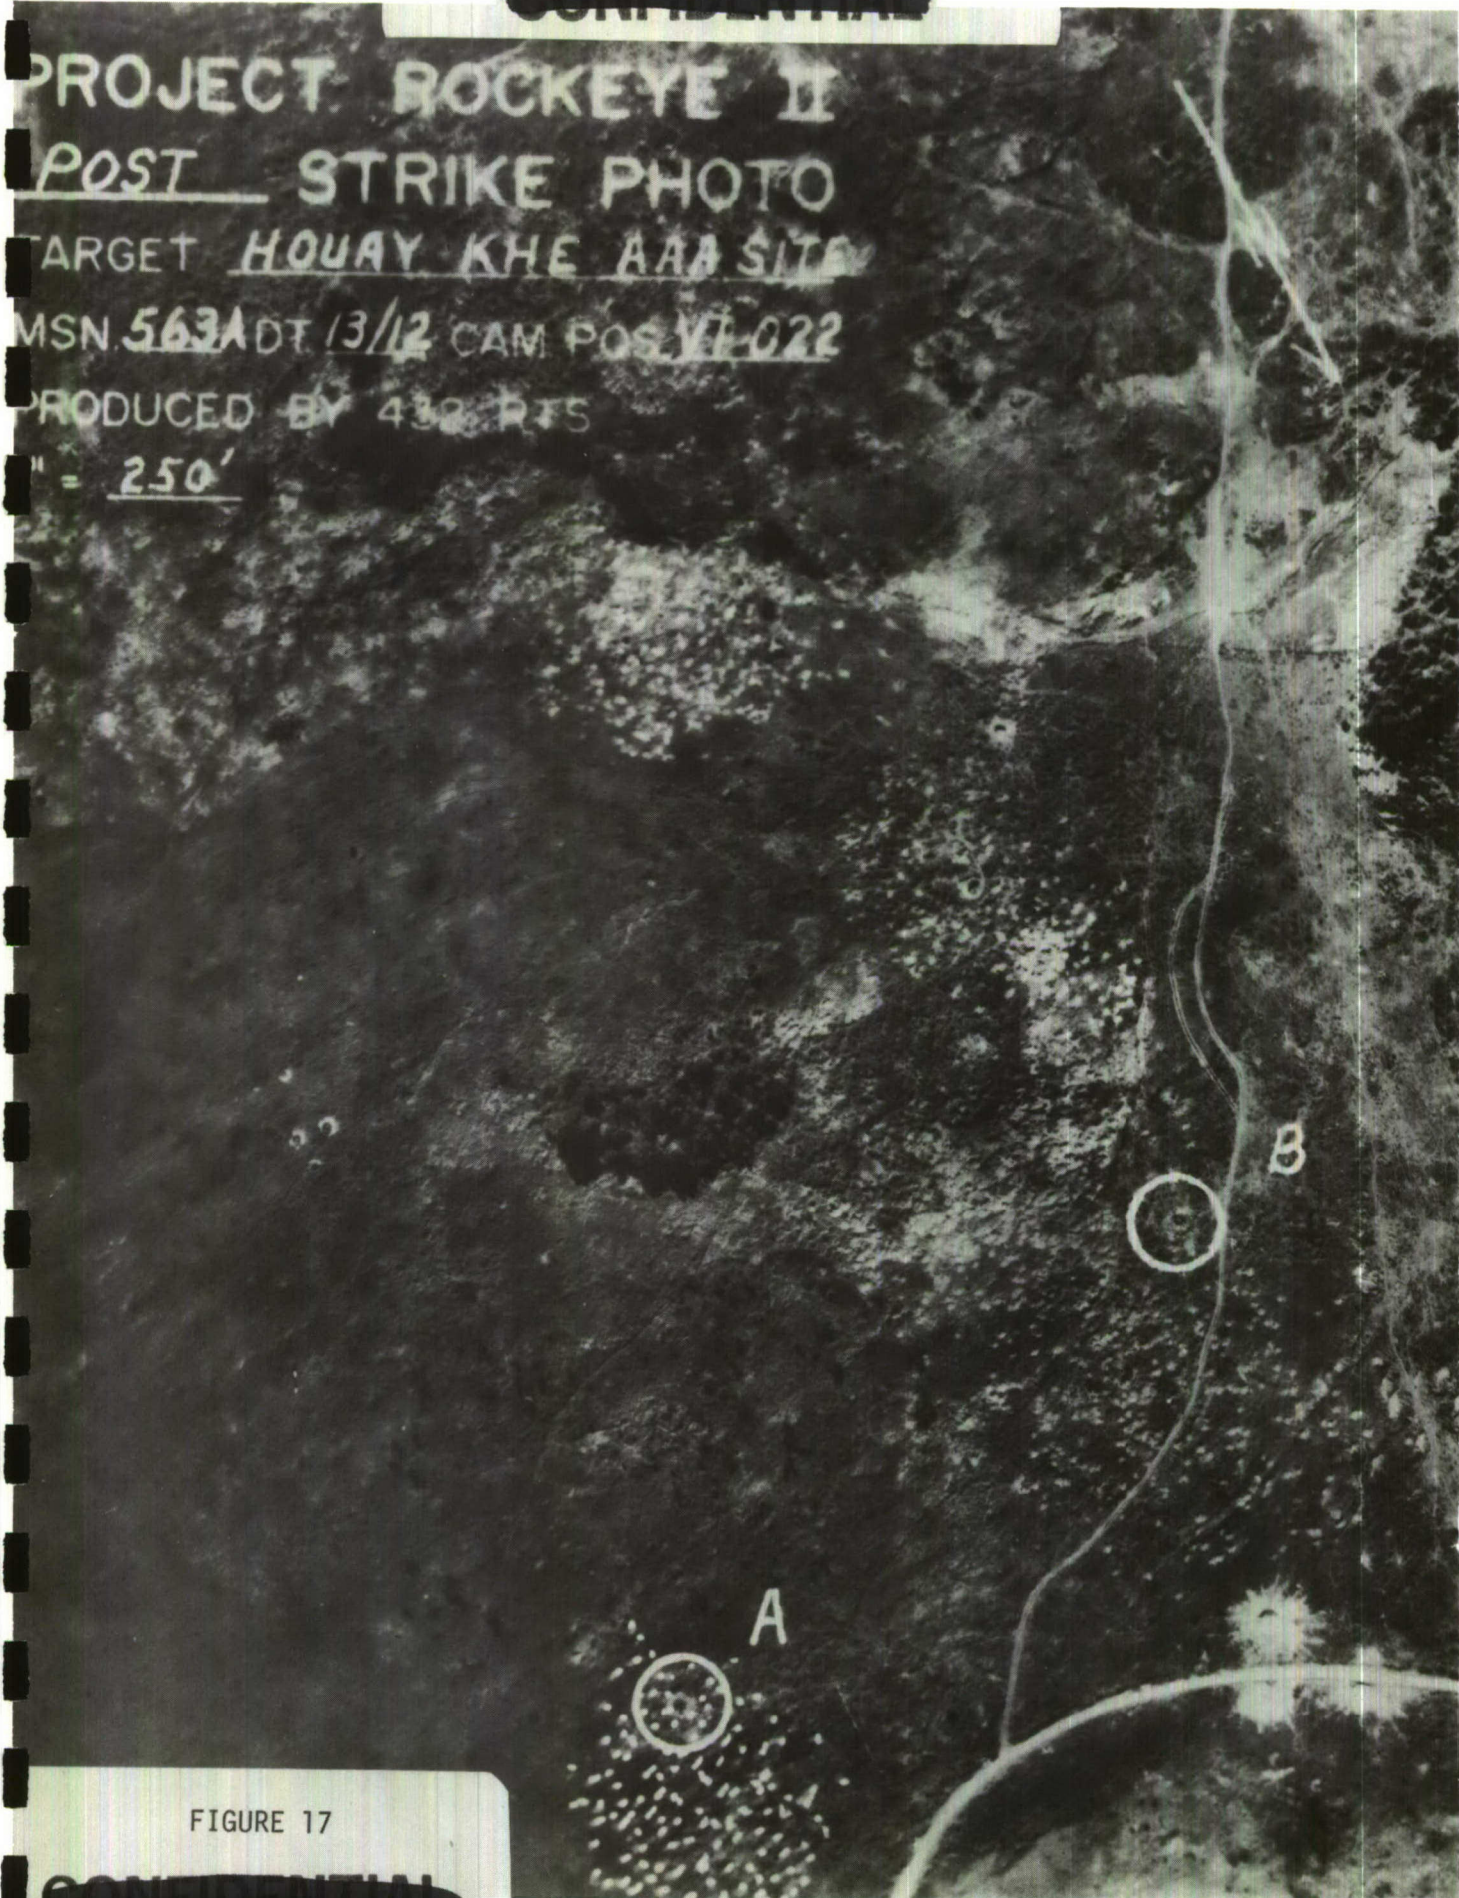
FIGURE 17

PROJECT ROCKEYE II
POST STRIKE PHOTO
TARGET HOUAY KHE AAA SITE
MSN 563A DT 13/12 CAM POS VI 022
PRODUCED BY 432 RTS
" = 250'
